Bridge Information System
Structure Level Report

Structures Management Plan SMP1

Structure Id 7799	Name Barron River
Crossing Name 	Alt. Name Post #255
Structure Type Bridge	Owner Transport and main Roads
Construction Type Girder/Beam	District 403 Far North
Construction Material Steel	LGA Id

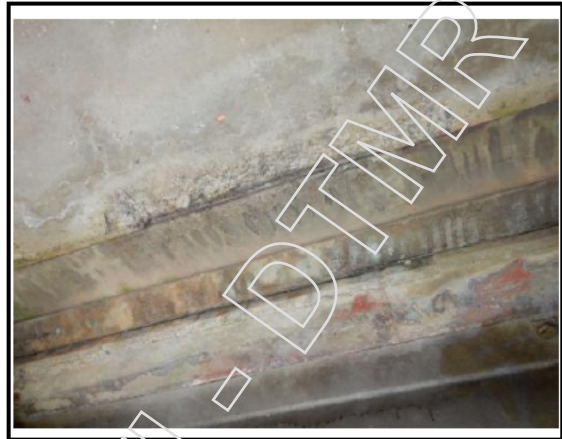
O S 5 D

Example of spalling in S5 deck at finger joint

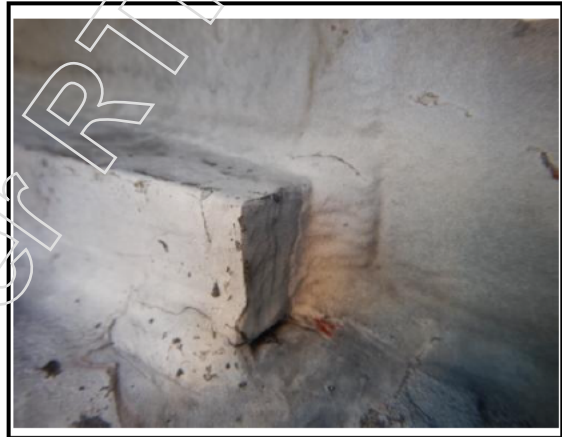
O S 5 G 1

Example of fine cracking at splice 2 S5

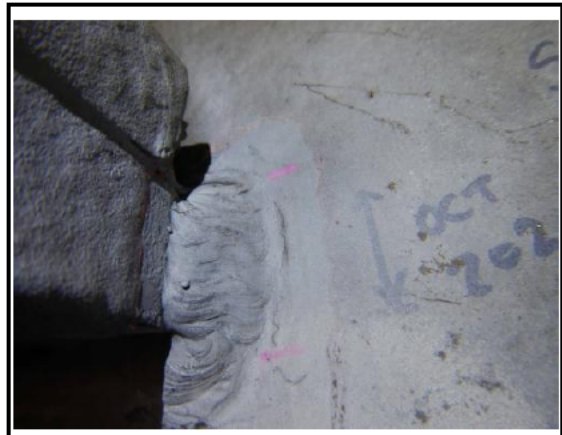
O S 5 G 1

Crack in weld S5 G1-XG3 interface

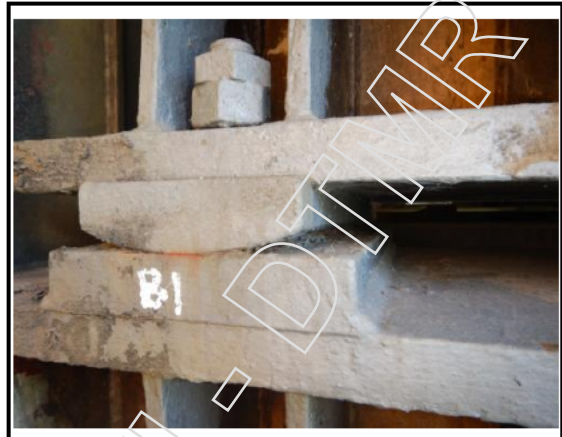
O P 5 B

Example of P5 bearing condition

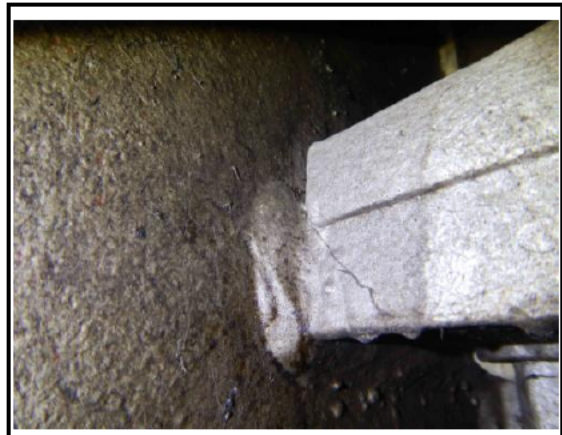
O S 6 G 2

Cracking at S6 G2-XG1 interface

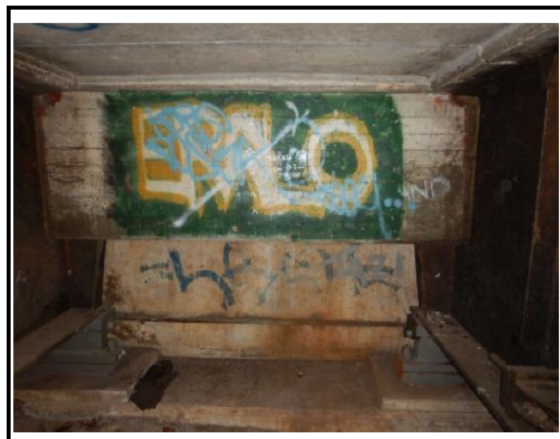
O S 6 XG 4

Example of cracking in S6 XG4

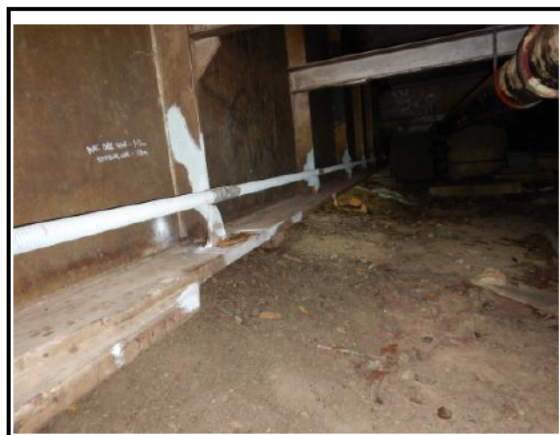
ST S 6 G 1

Showing replaced stressing bar
