# Structure Condition Inspection Report

Structure Id 817

Inspection Date 29-NOV-2020

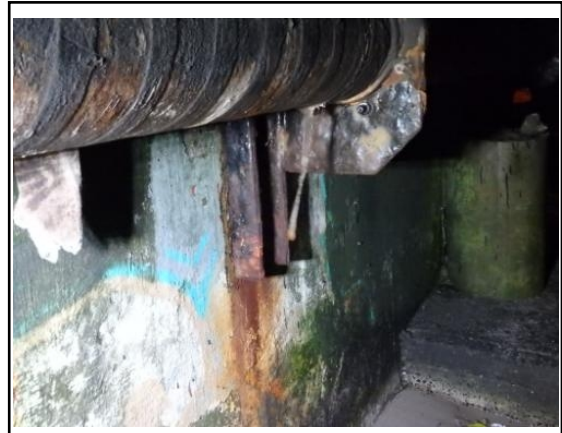
O  A  1  A

Corrosion on service bracket

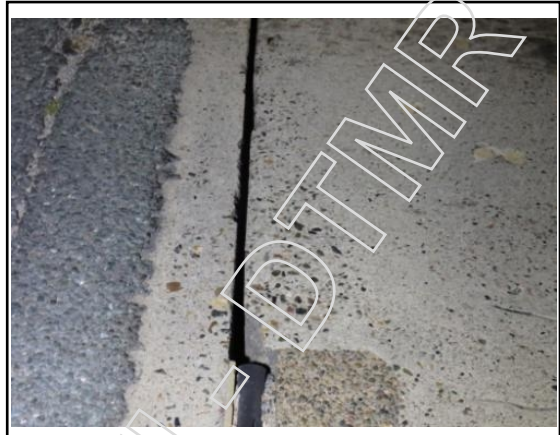
Mod	Category	Number	Comp Code	Comp No
O	A	1	J1

View of open joint

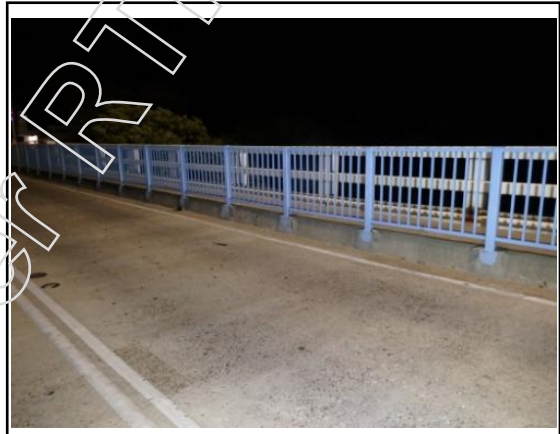
Mod	Category	Number	Comp Code	Comp No
O	S	1	BR

View steel barrier

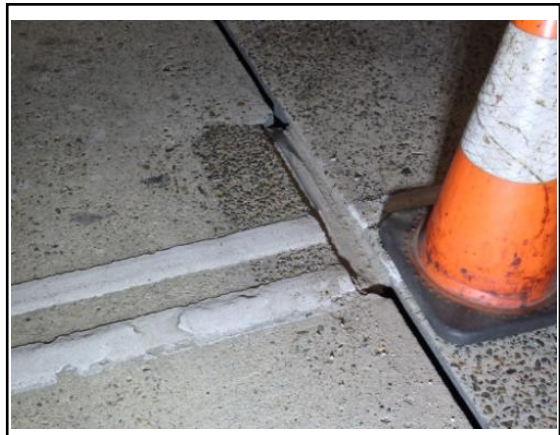
Mod	Category	Number	Comp Code	Comp No
O	P	1	J1

Rubber infill splitting 2

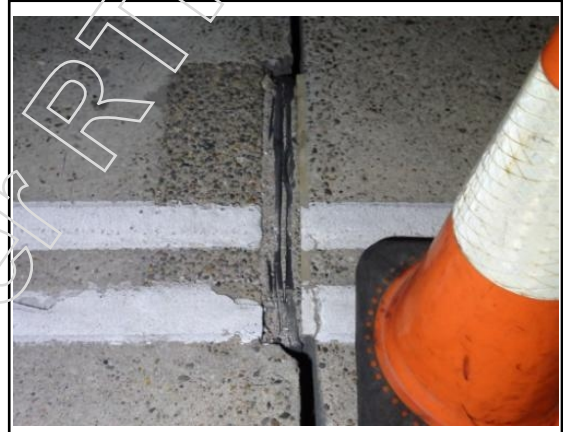
**Mod** O **Category** P **Number** 2 **Comp Code** J1 **Comp No**

**Description**  
Rubber infill splitting 2

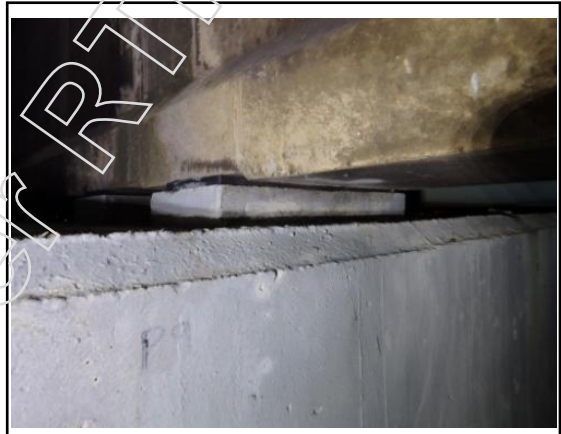
Mod	Category	Number	Comp Code	Comp No
O	P	9	B

Splitting & bulging

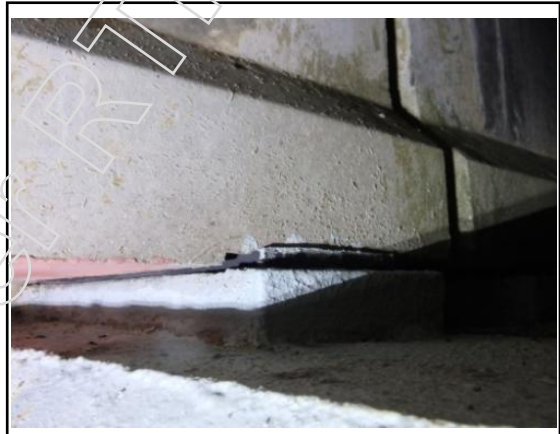
Mod	Category	Number	Comp Code	Comp No
O	P	11	B

Splitting & bulging

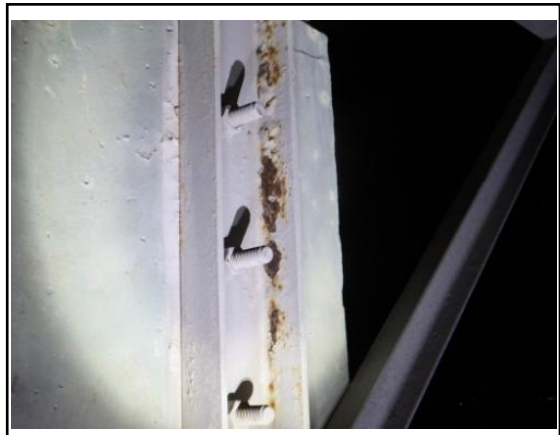
Mod	Category	Number	Comp Code	Comp No
O	P	11	H

Corrosion on bracket face 1

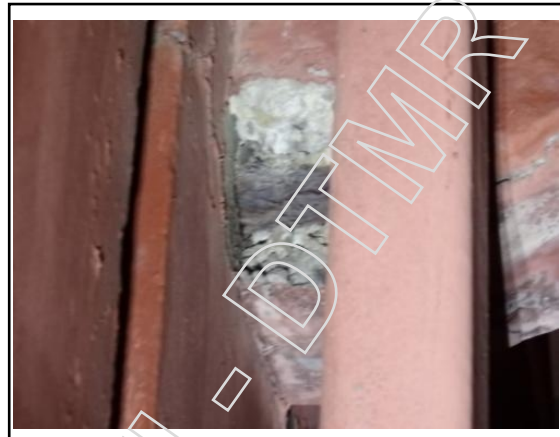
Mod	Category	Number	Comp Code	Comp No
O	S	12	XG	3

Spalling & steel exposed LHS

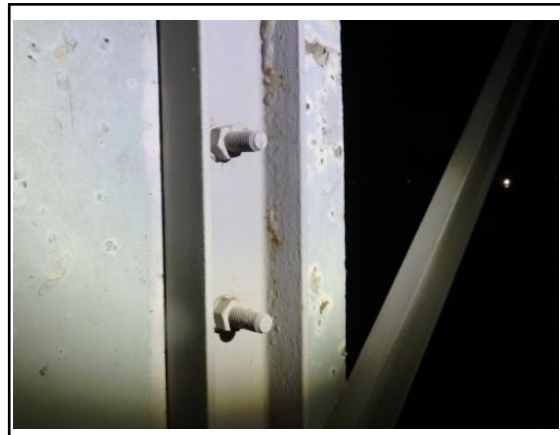
Mod	Category	Number	Comp Code	Comp No
O	P	13	H

Corrosion on bracket face 1

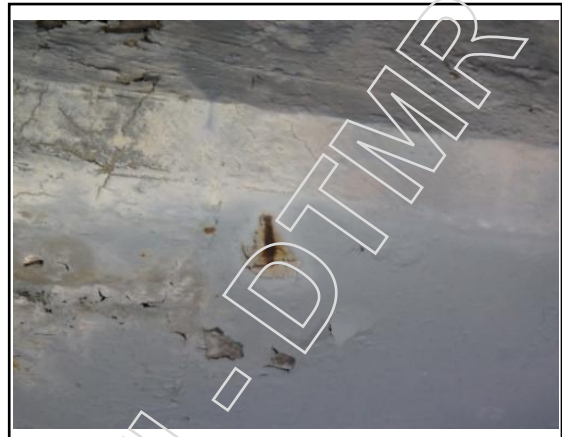
**Mod** O **Category** P **Number** 14 **Comp Code** H **Comp No**

**Description**  
Steel exposed

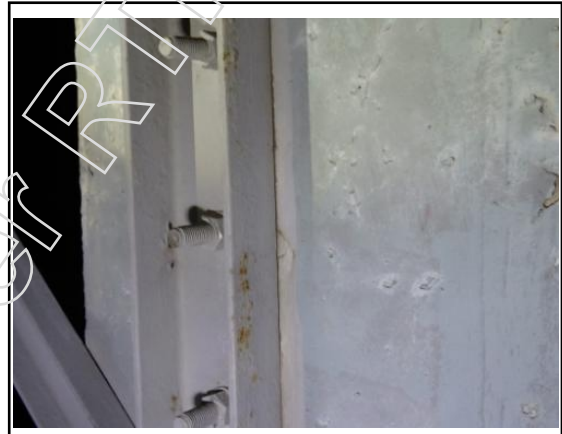
**Mod** O **Category** P **Number** 14 **Comp Code** H **Comp No**

**Description**  
Corrosion on bracket face 2

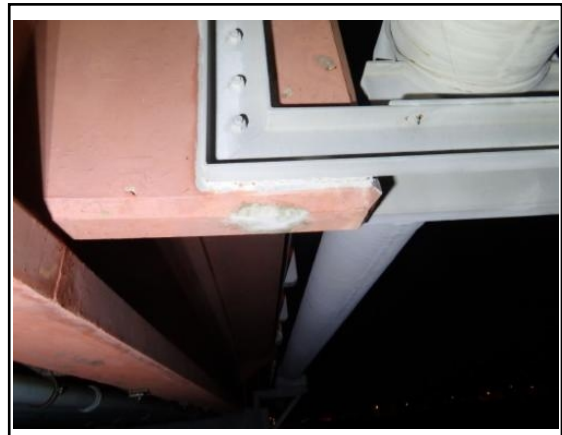
**Mod** O **Category** S **Number** 15 **Comp Code** XG **Comp No** 2

**Description**  
Repaired

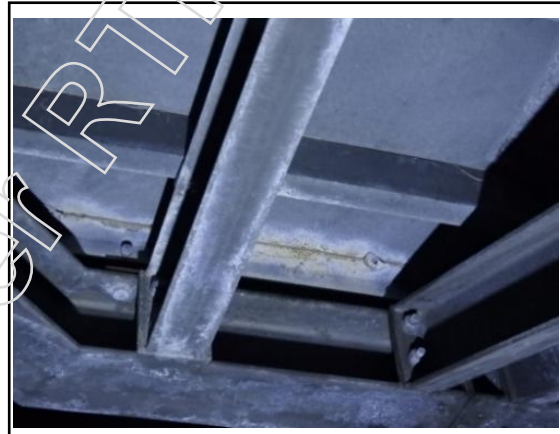
WL1 S 16 FY

Minor corrosion underview of passing bay

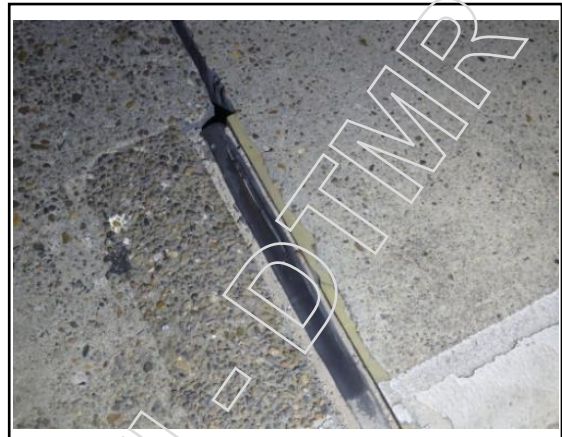
Mod	Category	Number	Comp Code	Comp No
O	P	10	J1

Rubber infill splitting 3

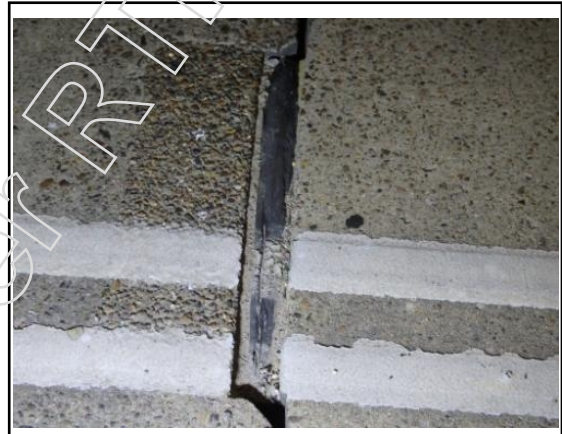
Mod	Category	Number	Comp Code	Comp No
O	P	10	J1

Rubber infill splitting 2

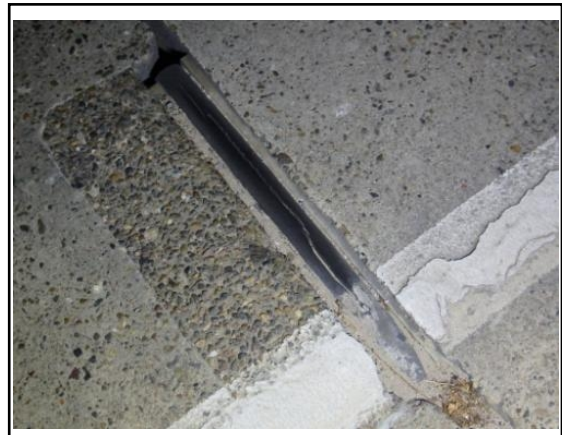
Mod	Category	Number	Comp Code	Comp No
O	P	11	J1

Rubber infill splitting 3

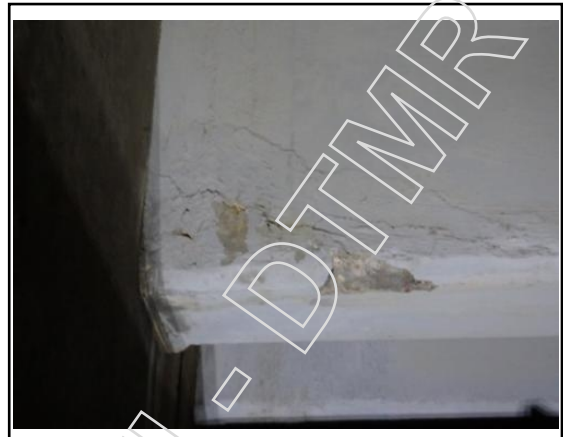
Mod	Category	Number	Comp Code	Comp No
O	S	18	XG	3

Starting to spall

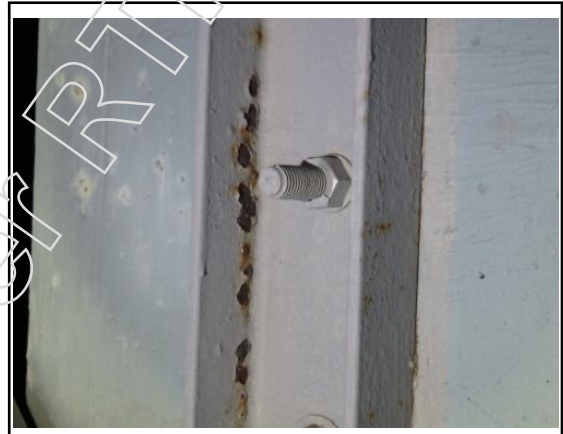
Mod	Category	Number	Comp Code	Comp No
O	P	18	H

Corrosion on bracket face 2

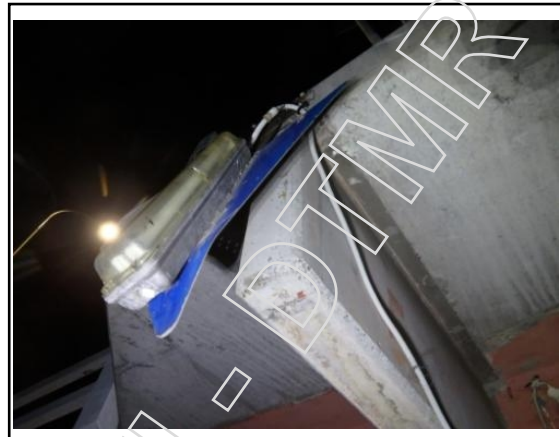
Mod	Category	Number	Comp Code	Comp No
WL1	S	19	K

Sign not fixed correctly

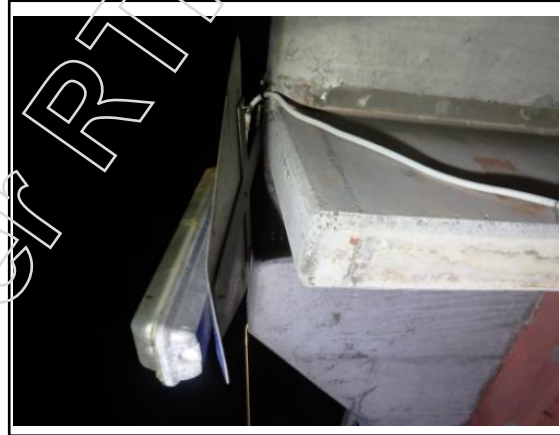
Mod	Category	Number	Comp Code	Comp No
WL1	S	19	K

Sign not fixed correctly

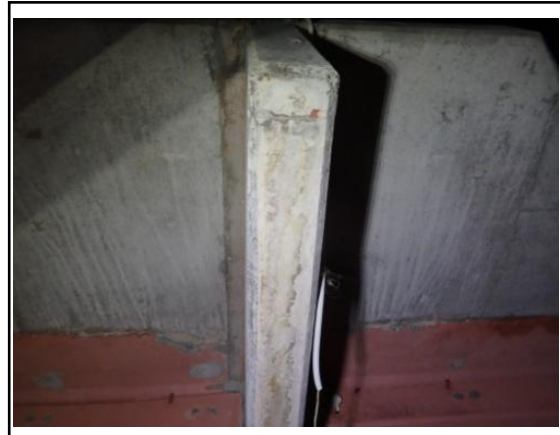
Mod	Category	Number	Comp Code	Comp No
WL1	S	19	FY

View of under side of passing bay
